GEOTECHNICAL AND STRUCTURAL ASSESSMENT REPORT

FISHER BORDER WALL
Mission, Texas

MEG Project No. 01-20-29170

Subject: Geotechnical and Structural Assessment Report
MEG Project No.: 01-20-29170
Fisher Border Wall
Mission, Texas

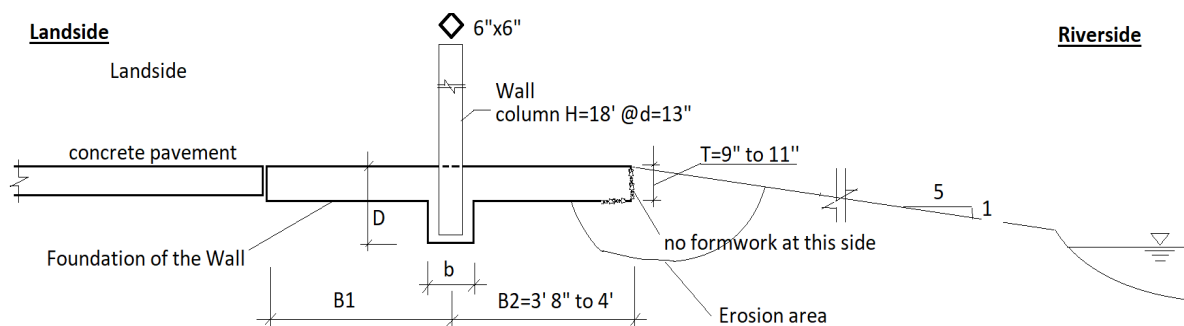
Figure 1: Typical Cross Section of the Fischer Bollard Wall

The wall together with its foundation and the surrounding soil is sketched in *Figure 1* below. The foundation type of the wall is cast-in-place strip foundation. As in *Figure 1*, the distances from the edge to the center of the foundation were designated as **B1** (on the US landside) and **B2** (on the river side). **B1** was estimated to be about 4.5 feet and **B2** was measured to be between 3 feet 8 inches to 4 feet. The depth of the foundation, **D**, was best estimated to be 2 feet. The distance of the wall to the nearest edge of the river is varied from 30 to 50 feet. The slope of the embankment at the riverside of the wall is varied from 3:1 to 5:1.

On the riverside, the thickness of the pour strip foundation, T , was measured at various locations and range from 9 inches to 11 inches in depth. It is our assessment that the pour strip was placed directly on untreated soil. This makes the quality of the concrete at the bottom of the foundation lessen leading to the reduction of the effective thickness of the strip. The strip foundation was not poured using forms or edge restraint and appears to be continuous as no isolation joints were easily visualized, see *Photo 5*. On the river side, many places show signs of spalling at the very edge of the foundation. There was no opportunity to obtain dimensions on the land side.

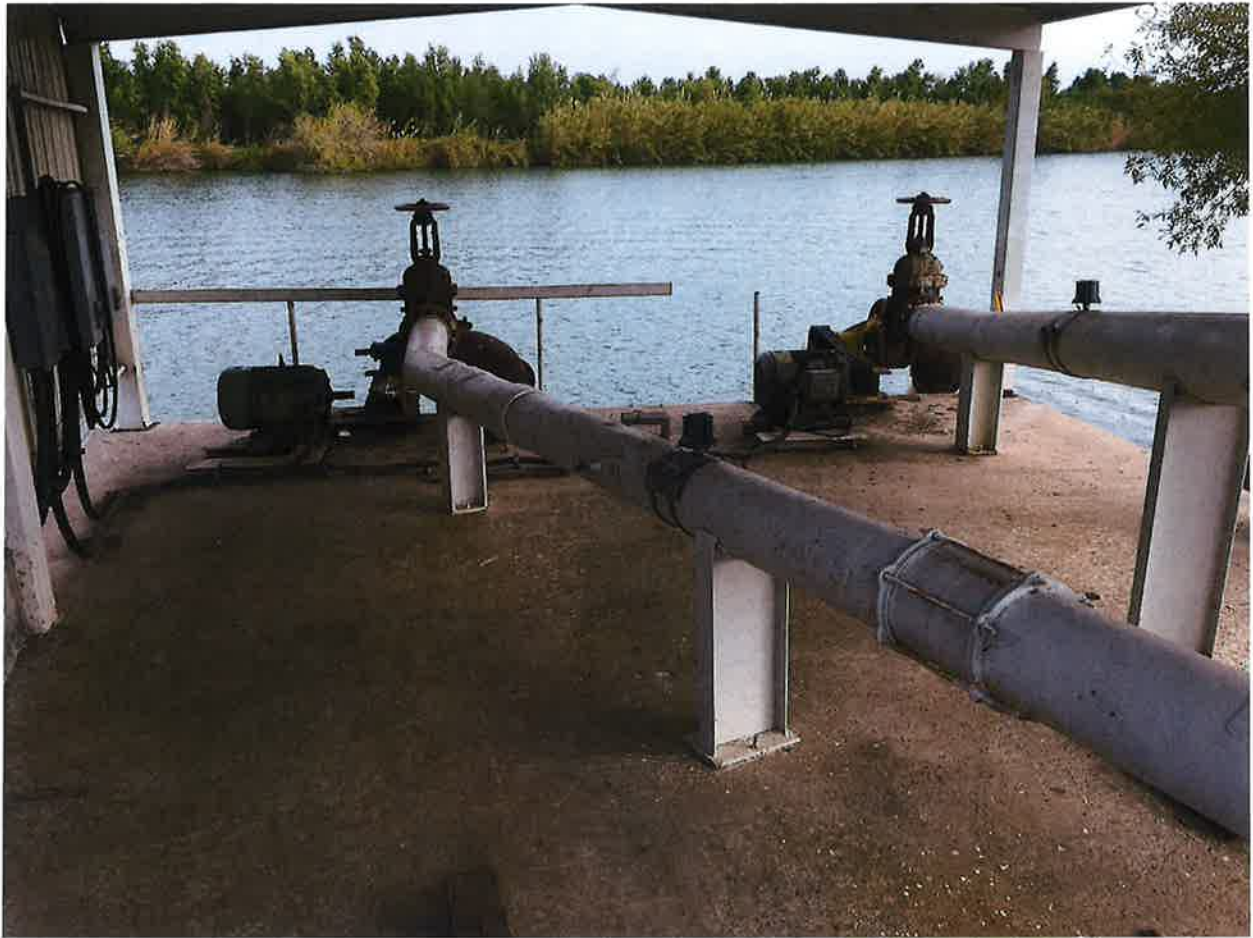
There is one power line on the property and 3 pumps. One small open sided structure is a concrete pad supporting two irrigation pumps on the bank of the river at RS 173.08. The floor level of this pump house structure would begin to become submerged in cases where the reservoir pool rises to elevation 107 or higher. A photo of this pump house is included below.

Figure 3. Photo of Irrigation Pumps at RS 173.08

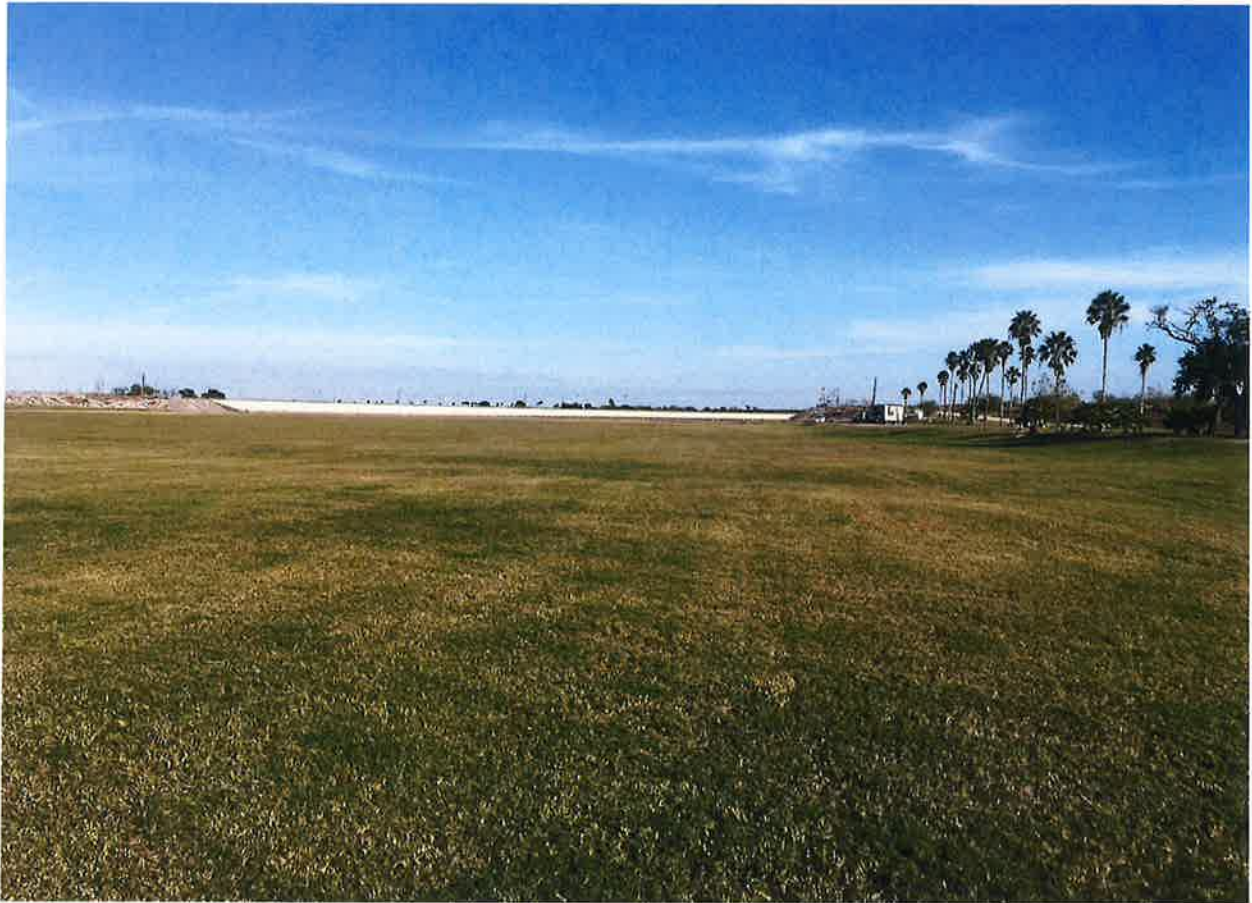
The Carrizo Cane has a relatively shallow root system which creates a condition where caving banks are more prevalent after the invasive plants have displaced the deeper rooted but slower growing grasses. There are many examples of improved bank protection on both sides of the river that demonstrate how well maintained and more stable grass cover will improve the bank.

Figure 4. Upstream area near the Main Floodway weir (looking downstream).

Well maintained grass cover to prevent scour.

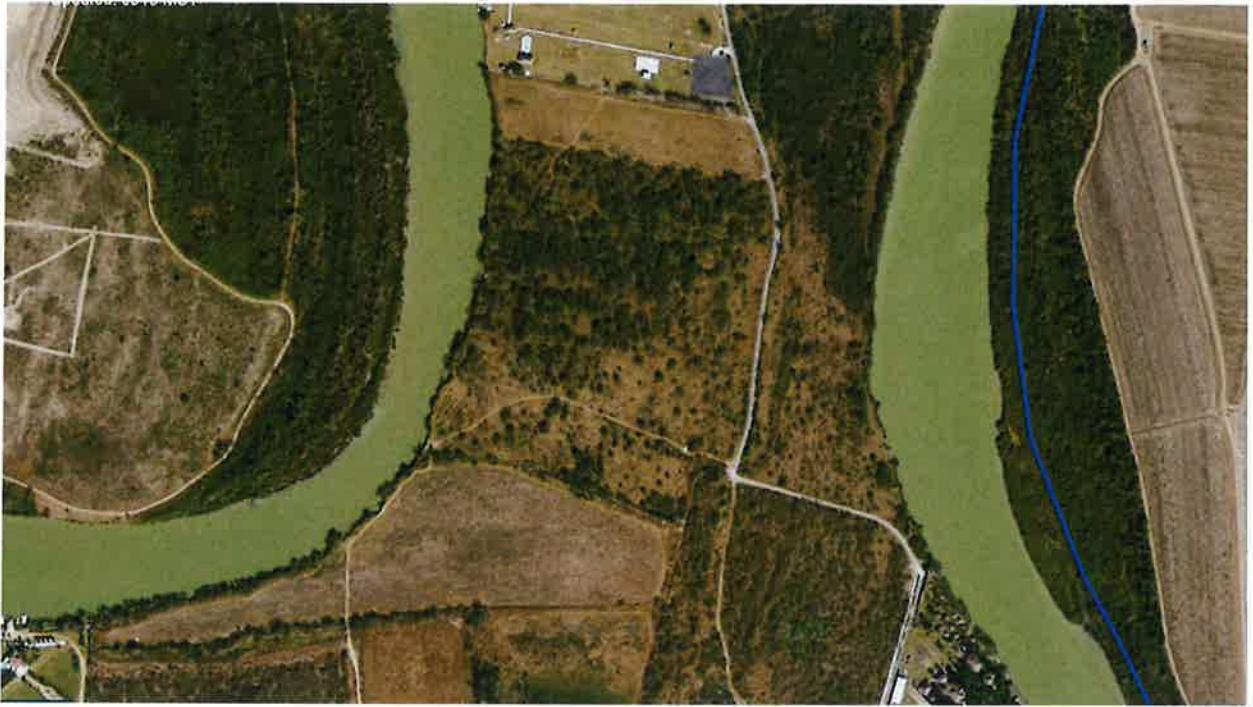
Figure 9. Rio Grande 2009

The two photos on the following page (figs. 9 and 10) show an example where a large event significantly eroded a bank in this same reservoir. It is noteworthy that the combination of the constricted river channel and the exposed vertical edge of the bank created the condition where significant erosion would occur. A complimentary and coordinated maintenance effort to establish gently sloped and protected riverbanks while taking every opportunity to eradicate the invasive Carrizo Cane will go a long way towards keeping the alignment of the river in the correct and mutually agreed upon location. This is a key issue with regard to protecting the river and the overbank areas from further damage and degradation. Figure 9 at the top of the following page shows the prior condition in 2009 with a relatively narrow channel (due to accretion on the inside of the bend) and a vertical exposed bank on the outside of the bend. Figure 10 at the bottom of page 10 shows the eroded area as photographed later in 2013.
